WHAT'S CRACKIN'?

SEPTEMBER 2021

Earthquake Response Executive Summary

Glenn Highway at Mirror Lake Take 2 - Construction

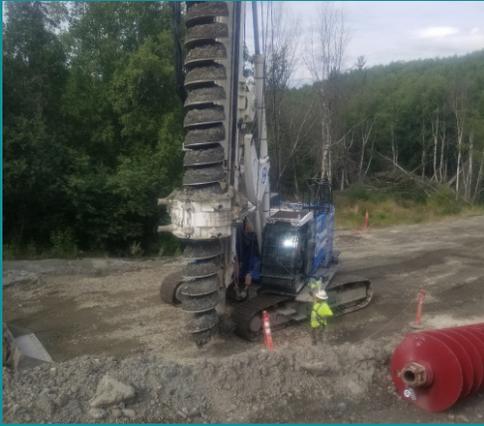
The 7.1 magnitude earthquake that struck southcentral Alaska on November 30, 2018, caused soil liquefaction at the toe of the roadway embankment supporting the Glenn Highway near Mirror Lake. When the soils liquified, they lost their strength and stiffness, and the embankment gave way triggering a massive roadway failure. DOT&PF acted quickly to restore the serviceability of the Glenn Highway immediately after the earthquake with a temporary repair, however, a more robust and permanent repair was needed to address the soft soil conditions supporting the Glenn Highway at the site.

A team led by John Thornley, PhD, PE of Golder Associates, developed an innovative design to restore the roadway durability to its pre-earthquake conditions using aggregate columns. This construction design includes over 1,500 auger-excavated holes, placed in a grid-like pattern, that are backfilled with gravel. After placement, the gravel is compacted, creating vertical columns that strengthen the roadway embankment. In the event of another significant earthquake, the aggregate columns will drain excess water from the soft soils, preventing liquification and the resulting failure.
